N J NO NAME DAM

NO 20

NJ 00472

PHASE 1 INSPECTION REPORT  
NATIONAL DAM SAFETY PROGRAM

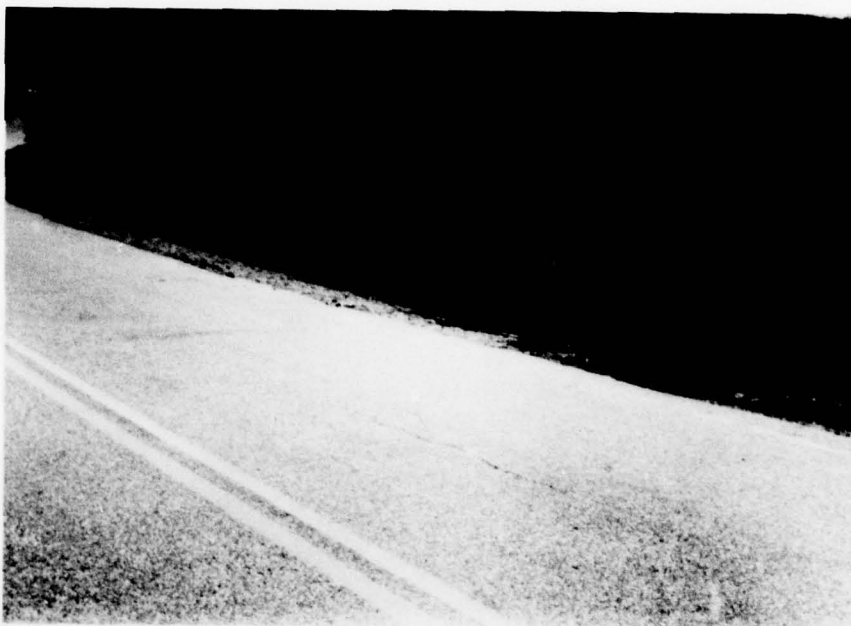
VISUAL EXAMINATION OF	OBSERVATIONS	REMARKS AND RECOMMENDATIONS
SURFACE CRACKS	Minor cracking in the paved road on top of the embankment. No other cracks apparent. Cracks do not appear to be related to movement of the embankment.	Monitor movements by surveying monuments.
UNUSUAL MOVEMENT OR CRACKING AT OR BEYOND THE TOE	The fill at the toe is saturated and covered with a growth of weeds. Toe is not well stabilized against local movement.	Conduct a study to investigate stability of the dam.
SLOUGHING OR EROSION OF EMBANKMENT AND ABUTMENT SLOPES	Slopes are not well defined, but are all approximately 2H:1V. Seepage in embankment has led to back-erosion, leaving dangerously narrow cross-sections. In other areas, dumping of spoil or water transported material have created abnormally wide sections. The worst washed-out area is opposite the turn in the road; here at least 30-40 cubic yards have been lost leaving a large local	Determine cross-sections at several locations. Replace material that has been eroded. gully.

Photo No. 3 - View of Pleasant Valley Road looking to the right. Note the crack in the pavement and the trees on the upstream slope of the embankment.

(1) All brush and trees should be removed from the downstream and upstream slopes to avoid problems which may develop from roots. The embankment face should then be seeded to develop a growth of grass for surface erosion protection.

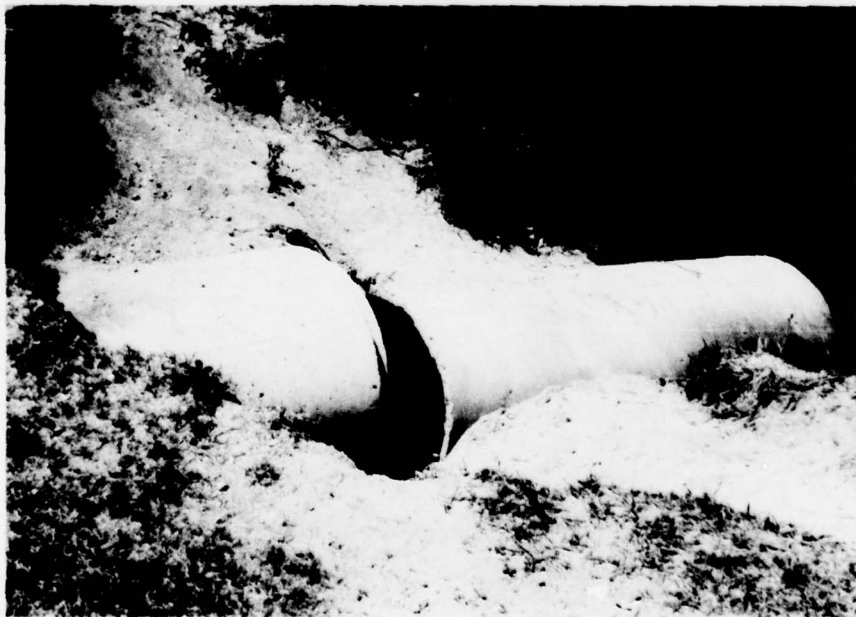
Photo No. 6 - Detail of the 27" diameter outlet discharging into the pond. Note the deteriorated condition. No flow was occurring at the inspection.

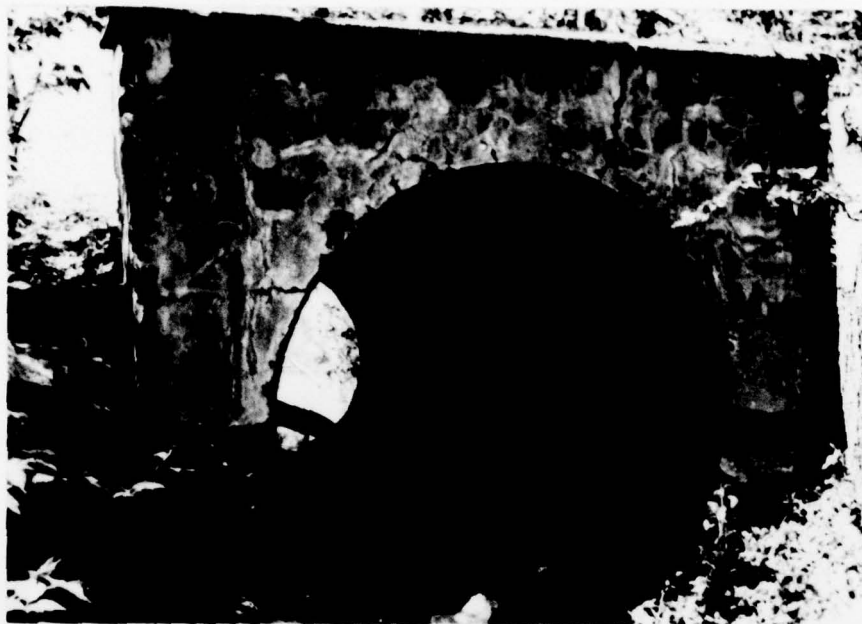
VISUAL EXAMINATION OF	OBSERVATIONS	REMARKS AND RECOMMENDATIONS
CRACKING & SPALLING OF CONCRETE SURFACES IN STILLING BASIN  N/A		
INTAKE STRUCTURE	The intake to the discharge culvert from the lake is a recessed basin, confined by low concrete retaining walls in good condition.	The intake has no trash screen and is prone to blockage with debris.
OUTLET STRUCTURE	Pleasant Valley Lake is drained by a 27 inch diameter reinforced concrete pipe culvert under Pleasant Valley Road. The pipe discharges into a drainage pond and is functional but deteriorated at its lower end.	The owner reports that the pipe is able to drain 2 feet off the lake in one day, when not obstructed.
OUTLET FACILITIES	The discharge pond is drained by a 5 foot diameter corrugated metal culvert which discharges onto the downstream embankment face. The culvert was partly blocked at the time of inspection. The headwalls of the culvert are structurally inadequate. Cracking is so extensive as to make them unfit for their purpose of securing the pipe and holding back fill.	Rebuild headwalls.

Photo No. 7 - View of 5 foot diameter Armco discharge culvert from the pond. Note deteriorated and cracked headwall. Headwall at other end has partly collapsed. The culvert drains directly onto the embankment face.

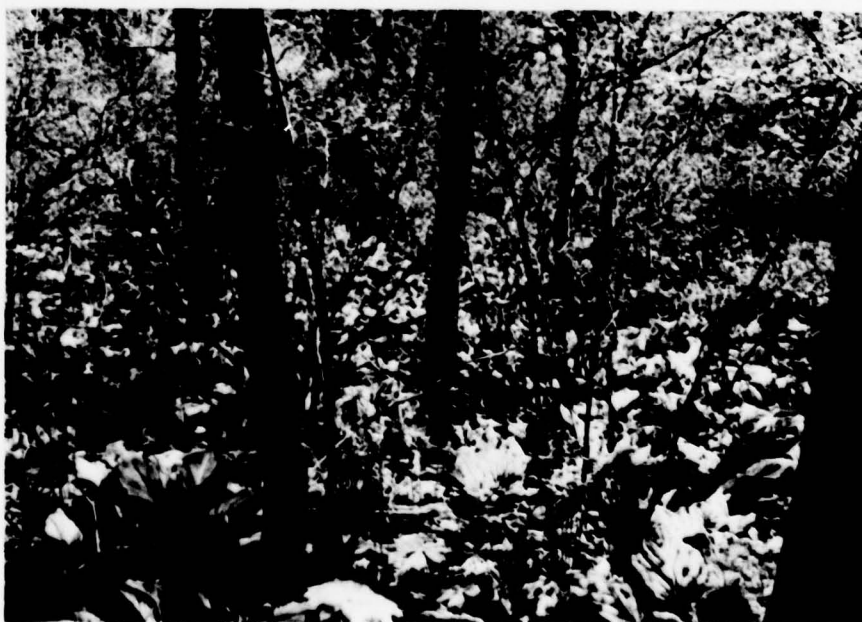
VISUAL EXAMINATION OF	OBSERVATIONS	REMARKS AND RECOMMENDATIONS
CONDITION (OBSTRUCTIONS, DEBRIS, ETC.)	Assessment and definition of slopes and stream is impossible due to heavy tree and brush growth. Many dead trees across the channel. The boundary between the gorge and the embankment is very indistinct. A single stream approx. 4 inch deep and 5 feet wide winds away through the gorge.	
SLOPES	Approximately 1.5H:1V. Heavily wooded with houses at the top of the slopes.	
APPROXIMATE NUMBER OF HOMES AND POPULATION	Playboy Club check booth, car park and recreational areas are all in flood path. No other private dwellings. Sussex 517 passes over stream.

Photo No. 12 - View of ill-defined downstream channel. Note heavy tree and brush growth.
